Truth in Sale of Housing Disclosure Report

Address: 1820 IRVING AVE N Minneapolis, MN

Evaluation Date: 6/25/2024

Evaluation #: 20242702

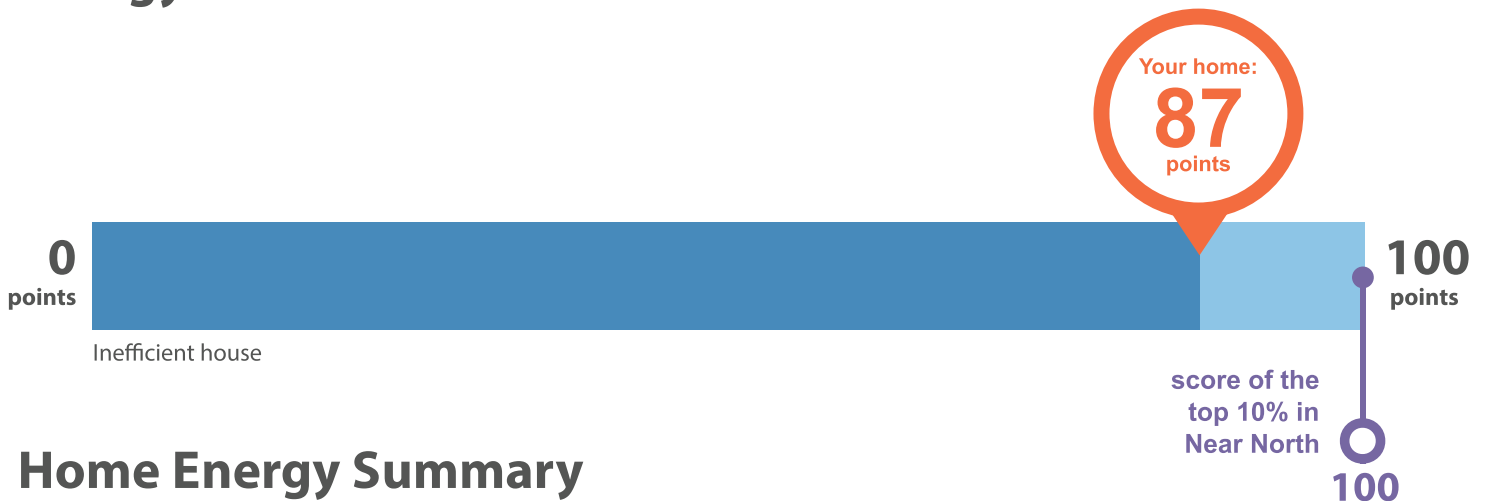
Energy Score

Your home is more energy efficient than most homes in Minneapolis, but there are still opportunities for improvement. Complete the cost-effective energy improvements on your report to improve the comfort of your home and increase its resale value. To learn more visit mncee.org/TISH or contact an Energy Advisor.
